Flood Control Project Maintenance
Levee Inspections

Fall 2013 Levee Maintenance Deficiency Summary Report

Sacramento River Basin

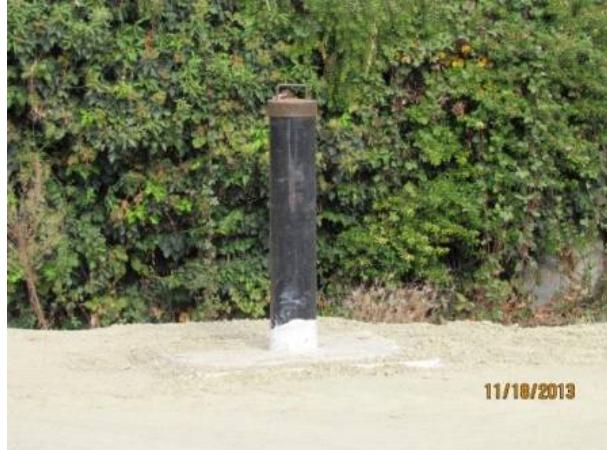
Levee Mile Report Line	1
Start Levee Mile	0.02
End Levee Mile	0.02
Location	Land Side
Category	Earthen Levee
Item	Encroachments
View of the monitoring well standpipe on the landside levee hinge.	
mhashch_f_20131120_715.JPG

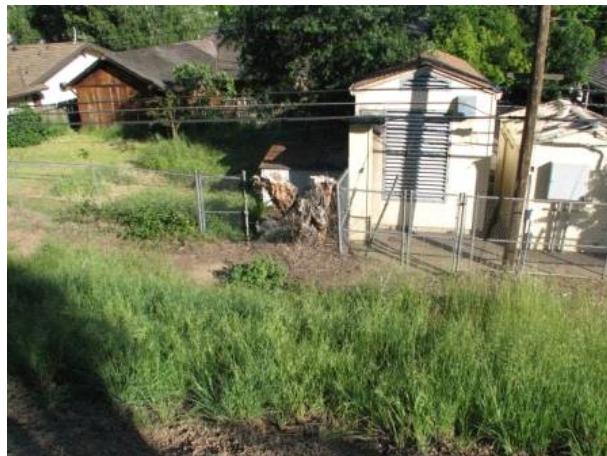
Levee Mile Report Line	3
Start Levee Mile	0.45
End Levee Mile	0.45
Location	Land Side
Category	Earthen Levee
Item	Trim / Thin Trees
Tree trunk at fence line.	
mhashch_f_20130923_112.jpg

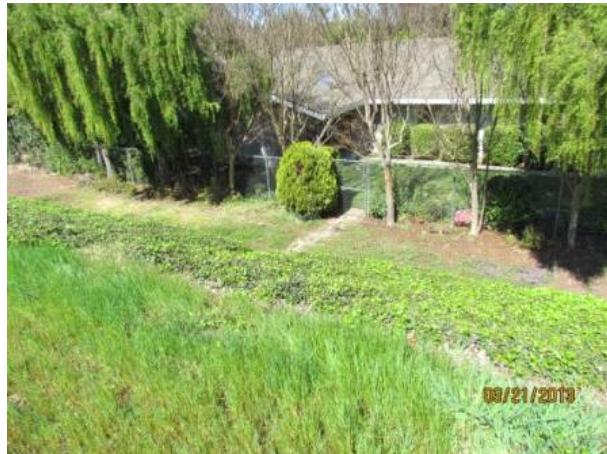
Levee Mile Report Line	4
Start Levee Mile	1.13
End Levee Mile	1.13
Location	Land Side
Category	Earthen Levee
Item	Vegetation
View of the landscaping at the levee toe.	
mhashch_f_20130923_109.JPG

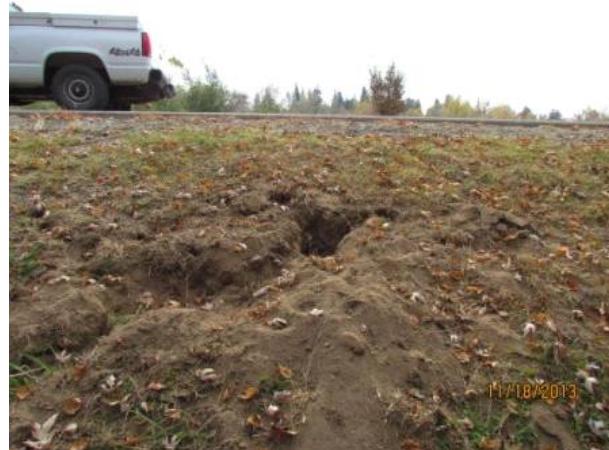
Levee Mile Report Line	5
Start Levee Mile	1.74
End Levee Mile	1.74
Location	Land Side
Category	Earthen Levee
Item	Animal Control
View of the rodent hole on the landside levee slope.	mhashch_f_20131120_716.JPG

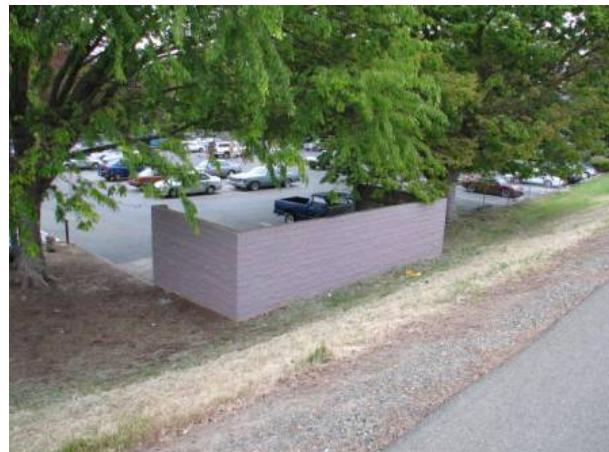
Levee Mile Report Line	7
Start Levee Mile	1.94
End Levee Mile	1.94
Location	Land Side
Category	Earthen Levee
Item	Encroachments
4/13/2011 Cinderblock trash enclosure is encroaching in the toe of the levee.	mhashch_f_20130923_110.jpg

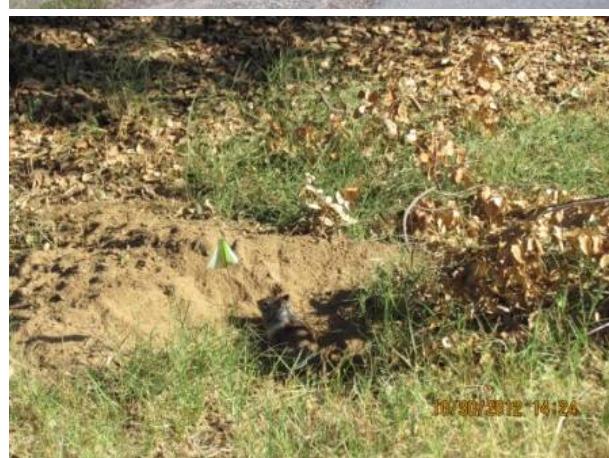
Levee Mile Report Line	8
Start Levee Mile	3.01
End Levee Mile	3.01
Location	Land Side
Category	Earthen Levee
Item	Animal Control
View of active rodent burrow at landside levee toe.	mhashch_f_20130923_111.JPG

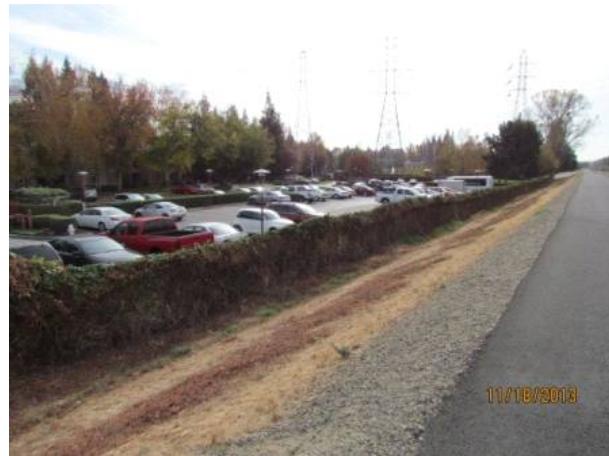
Levee Mile Report Line	9
Start Levee Mile	3.11
End Levee Mile	3.24
Location	Land Side
Category	Earthen Levee
Item	Encroachments
View of the trimmed vegetation on the chain linked fence still obstructing visibility.	
mhashch_f_20131120_714.JPG

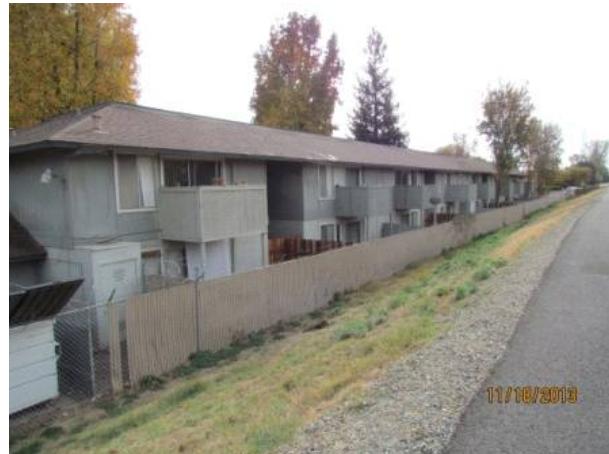
Levee Mile Report Line	10
Start Levee Mile	3.24
End Levee Mile	3.32
Location	Land Side
Category	Earthen Levee
Item	Encroachments
View of the fence at the landside levee toe.	
mhashch_f_20131120_713.JPG

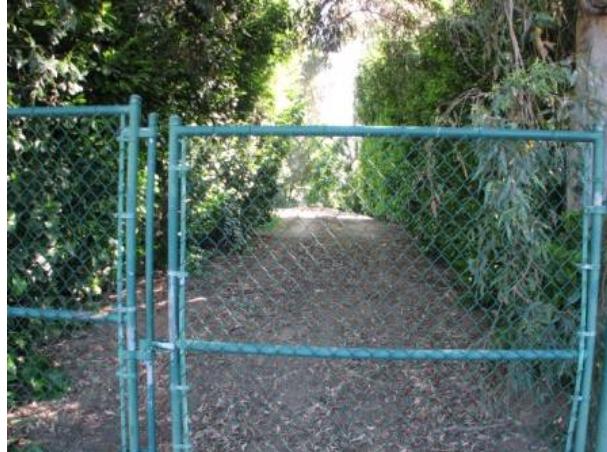
Levee Mile Report Line	1
Start Levee Mile	0.00
End Levee Mile	0.70
Location	Crown
Category	Earthen Levee
Item	Encroachments
Levee encroached on by property owners north of Arden.	
mkhashch_f_20130923_116.jpg

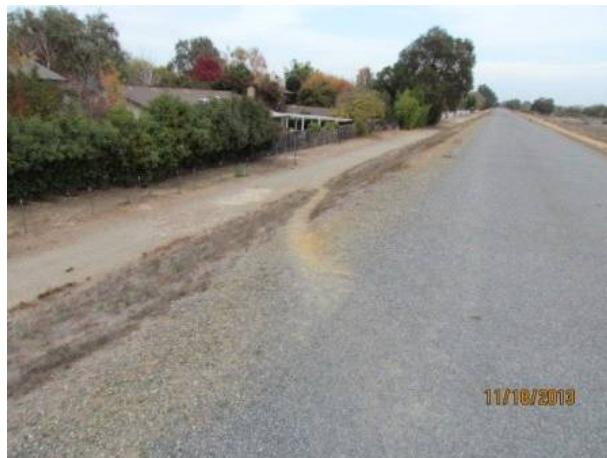
Levee Mile Report Line	3
Start Levee Mile	2.51
End Levee Mile	2.51
Location	Land Side
Category	Earthen Levee
Item	Slope Stability
View of the pathway on the landside levee slope.	
mkhashch_f_20131120_718.JPG

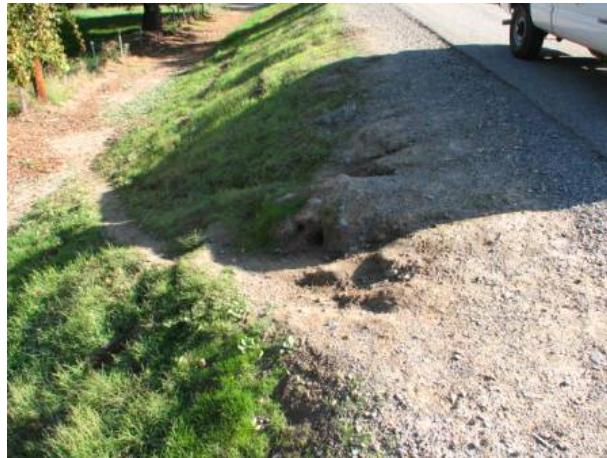
Levee Mile Report Line	4
Start Levee Mile	3.37
End Levee Mile	3.37
Location	Land Side
Category	Earthen Levee
Item	Erosion / Bank Caving
11/16/2011 Erosion from pedestrian traffic, burrow can be seen in the photo in the lower portion of the shadow.	
mkhashch_f_20130923_117.jpg

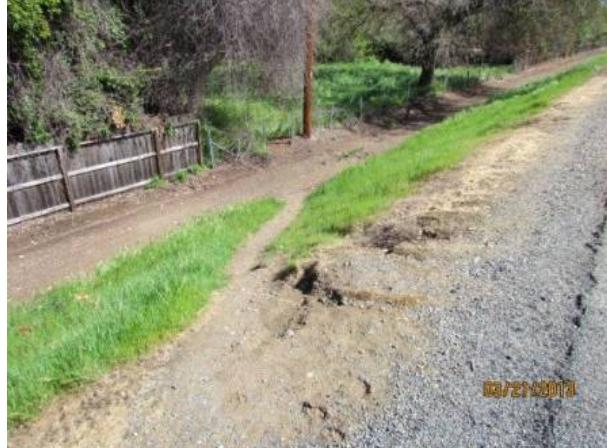
mkhashch_f_20130923_118.JPG

View of the erosion on the landside levee slope from pedestrian traffic.

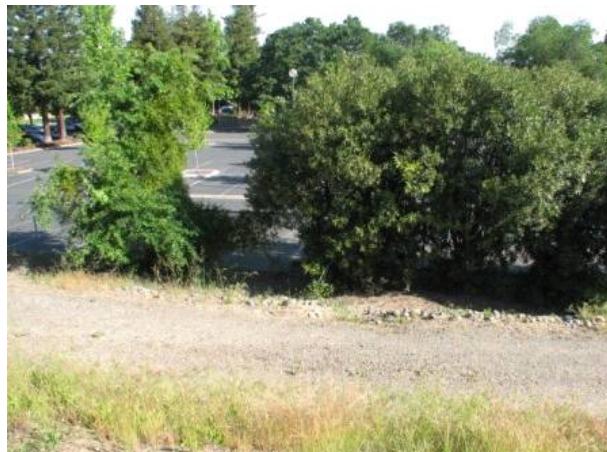
Levee Mile Report Line	5
Start Levee Mile	3.58
End Levee Mile	3.58
Location	Land Side
Category	Earthen Levee
Item	Vegetation

Trees at fence line obstruct access and visibility.

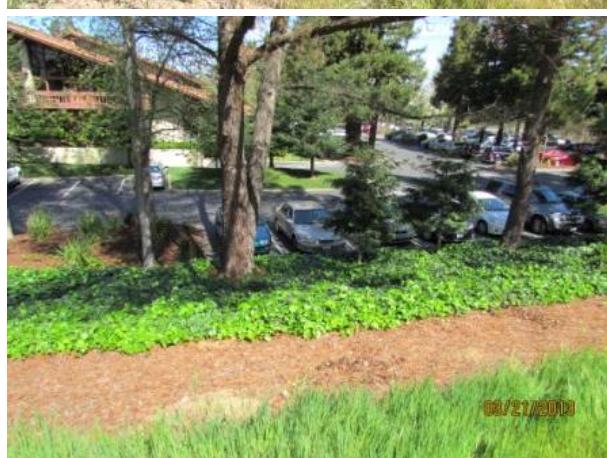
Levee Mile Report Line	6
Start Levee Mile	3.64
End Levee Mile	3.64
Location	Land Side
Category	Earthen Levee
Item	Vegetation

View of the landscaping at the levee toe.

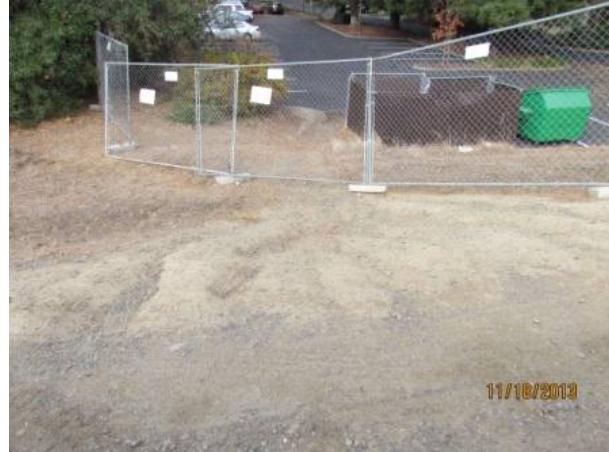
Levee Mile Report Line	7
Start Levee Mile	3.87
End Levee Mile	3.87
Location	Land Side
Category	Earthen Levee
Item	Slope Stability
View of the erosion on the landside levee slope caused by pedestrian foot traffic.	
mhashch_f_20131120_717.JPG

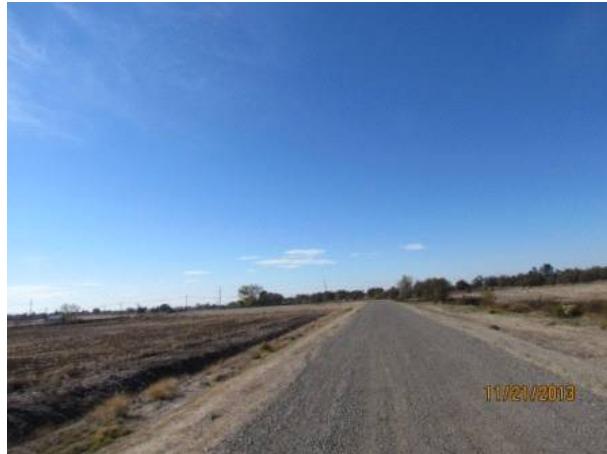
Levee Mile Report Line	4
Start Levee Mile	0.62
End Levee Mile	0.62
Location	Land Side
Category	Earthen Levee
Item	Vegetation
View of the acceptable vegetation control on the levee slopes.	
mkhashch_f_20131121_744.JPG
